RADIUS PROJECT OF GUAYAQUIL - ECUADOR

**Risk Assessment tools for Diagnosis of
Urban areas against Seismic disasters**

GUAYAQUIL CITY FINAL REPORT

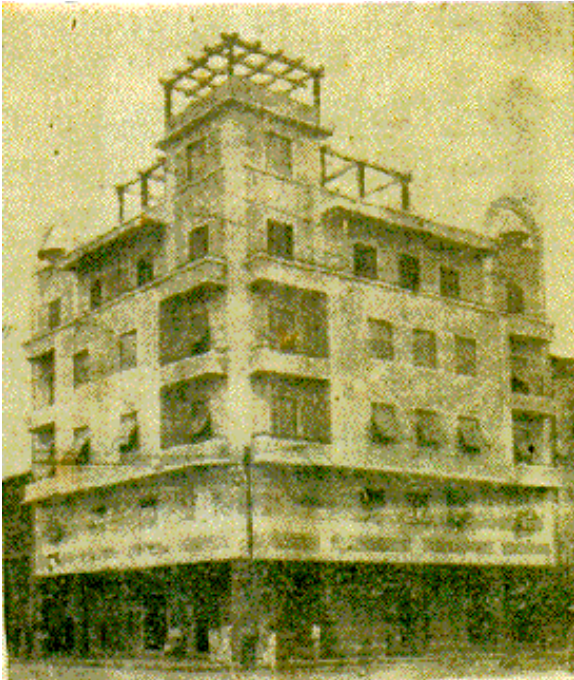
There were 40 people who died, the main cause being crushing, because of the total collapse of buildings. Forty three persons were taken out alive from the debris of the buildings, 21 of them fatally injured. There were 11 people injured in other parts of the Central Zone, the majority of them because of fallen debris from walls or roofs. The largest number of deaths occurred in the total collapse of a five story building where Clinica Arreaga was functioning. See figure 3.

Figure 3. Building of Arreaga Clinic that collapsed during the earthquake.

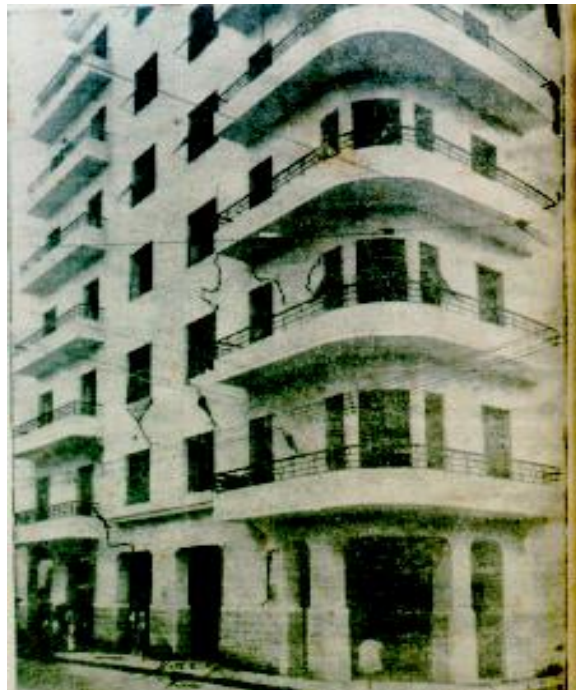
The largest losses occurred to reinforced concrete buildings, three buildings of 4 to 5 stories collapsed and many buildings of more than 3 stories suffered a lot of damage, five of them were later demolished [15]. Other buildings suffered different degrees of damage: cracking of columns and walls, falling of facades and walls, interior damage and inclined buildings. The majority of damage always occurred on the first and second floors. See figure 4.

Figure 4. Building of Hotel Pauker. It suffered heavy damage and was ordered to be demolished in 1942.

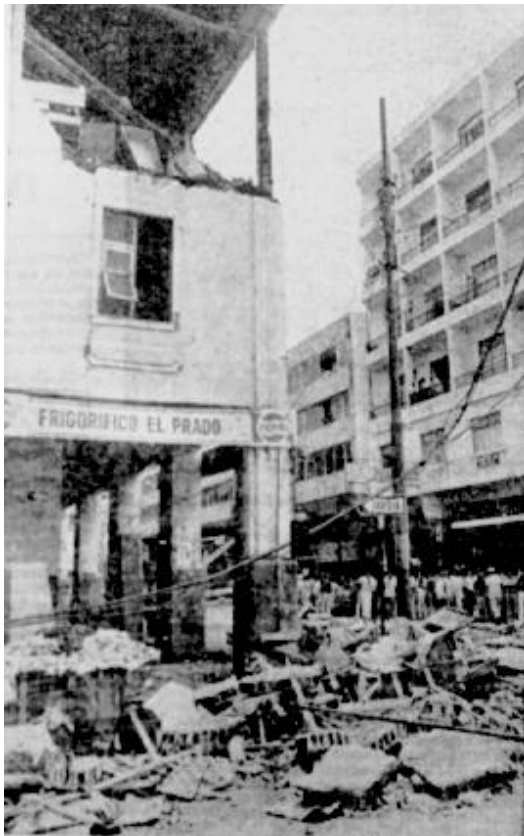
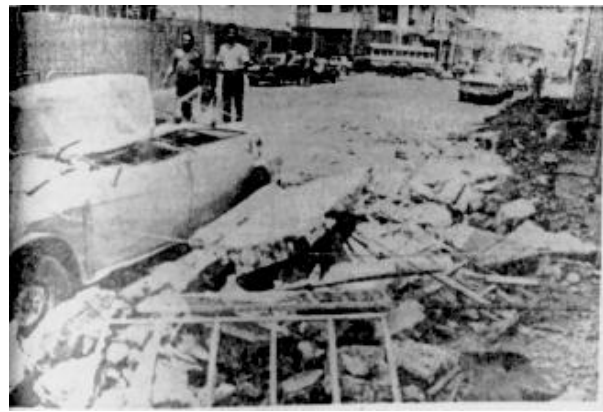
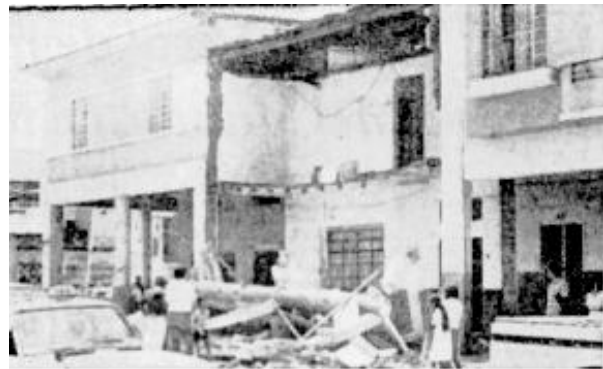
The aftermath of the earthquake: 49 “mixed” houses had to be demolished in the Parroquias of Bolivar, Ayacucho, Sucre and Garcia Moreno, in the Central and South Zones of the City. If we consider that the earthquake was reported with an Intensity of VII degrees, it must be accepted that a future earthquake with an Intensity of VIII degrees would destroy the majority of these houses. The age of the affected structures ranged between 20 and 40 years old. Nowadays the structure of these houses has deteriorated and many of them are over 40 years old. See figure 5.

Figure 5. Damage in “mixed” structures during the earthquake of August 18, 1980.

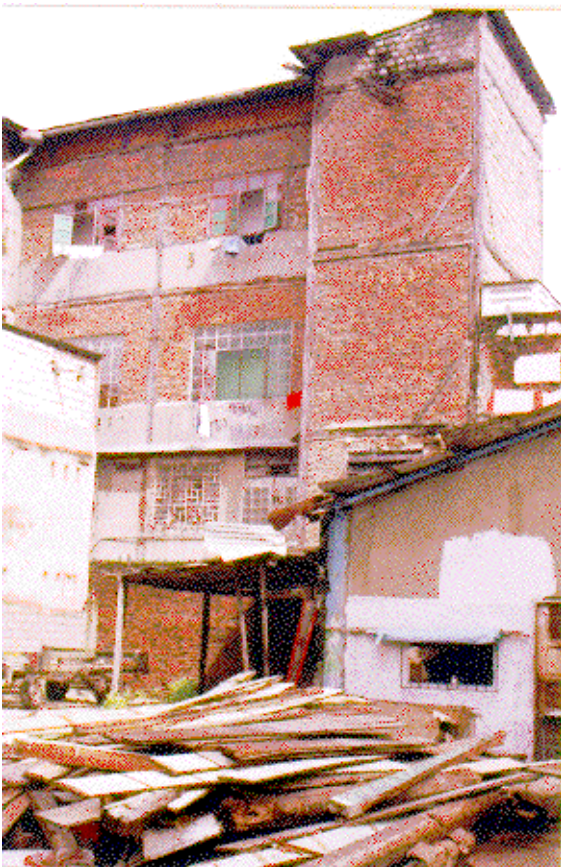
Figure 6. “Mixed” houses have the highest risk of collapse, many of them are over 40 years old, and their wood structure has deteriorated with poor confinement of brick walls within the wooden frames. There are more than 200 buildings of this type in the Central Zone of the City.

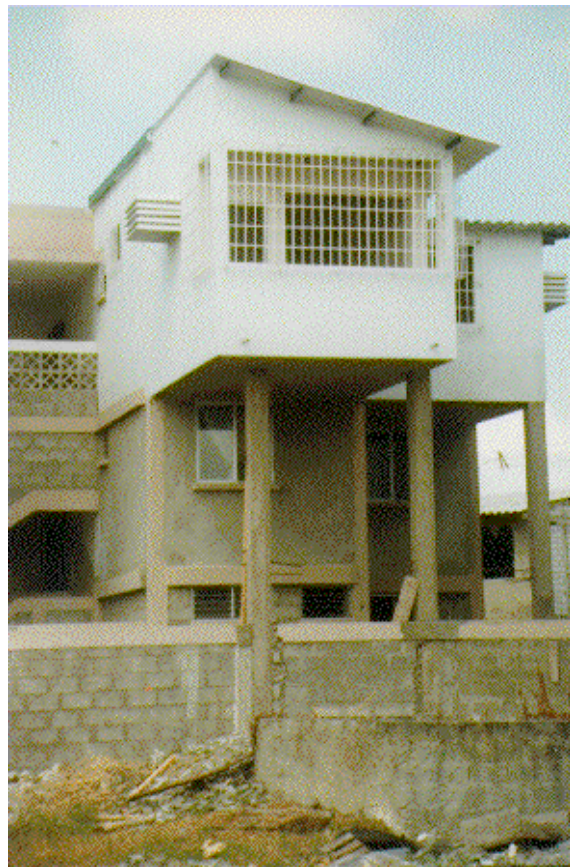
Figure 7. Condominium BEV-BM6. Especially in the North Zone, many reinforced concrete structures do not follow seismic codes. This structure is located in Saucos IX, and has been remodeled without technical supervision. The result is the increase in its seismic risk in a zone initially characterized by its low risk [2].

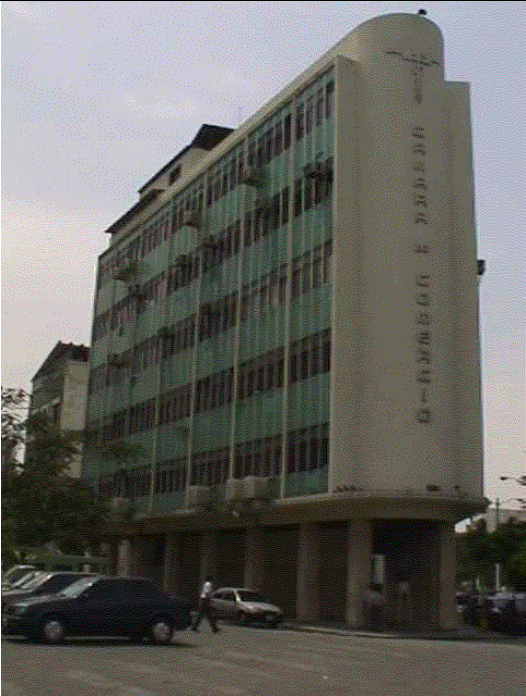
<p>Chamber of Commerce Building: Minor damage and partial destruction of walls during the 1980 EQ.</p>

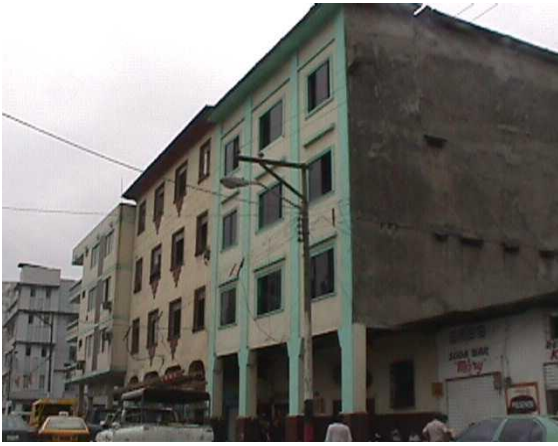
Figure 19. Example of a mixed building of four levels in very poor condition, type D.

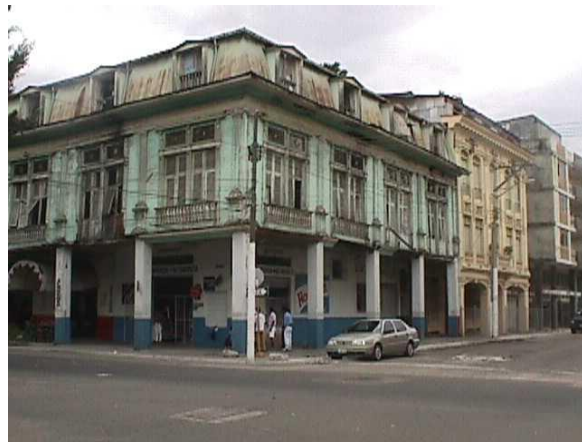
Figure 20. Example of a very old wooden house and in very poor condition, type C.

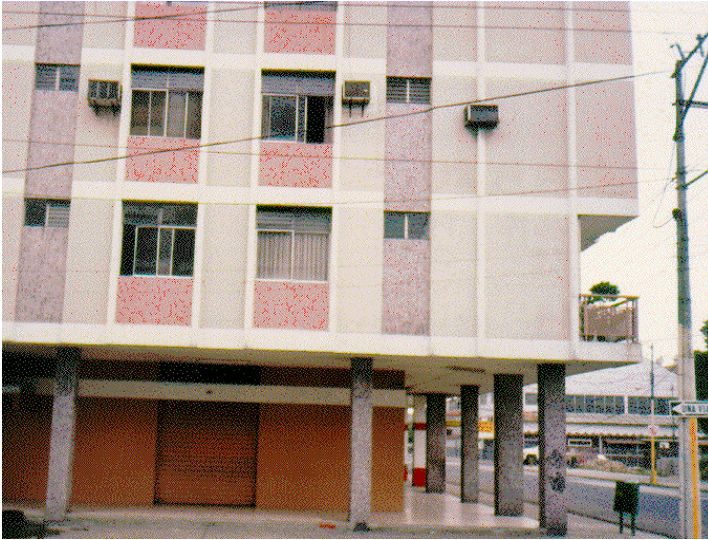
Figure 21. Reinforced concrete building, built between 1930 and 1970, which has many risk factors: weak columns, soft first story, and located at a corner. It belongs to type H.

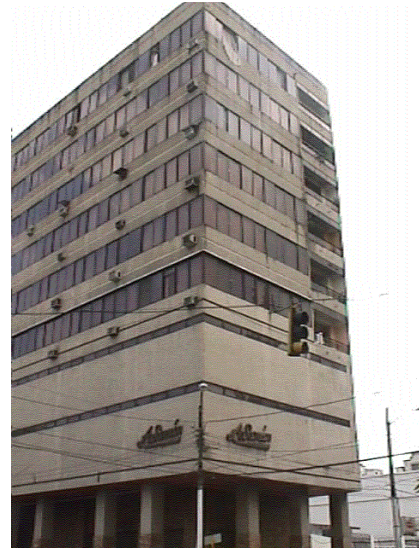
Figure 22. Building with “portal” and mezzanine, defined as a soft first story. It belongs to type I.

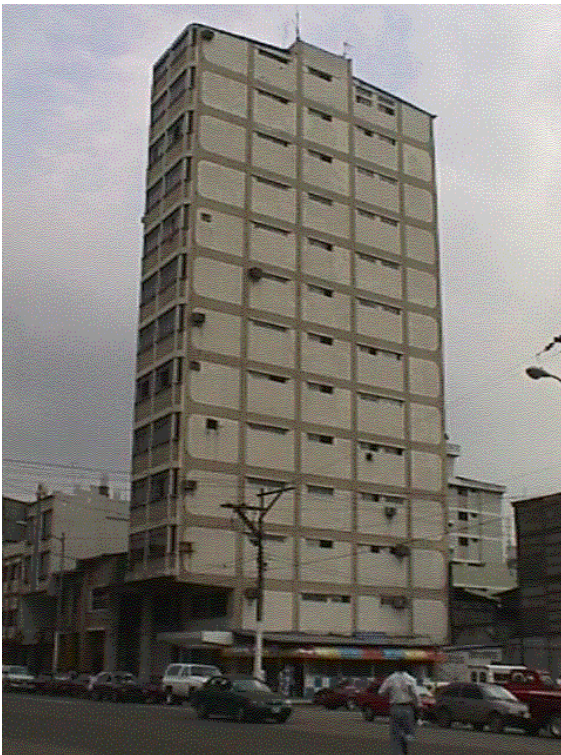
Figure 23. Example of type I building, with a critical slenderness ratio.

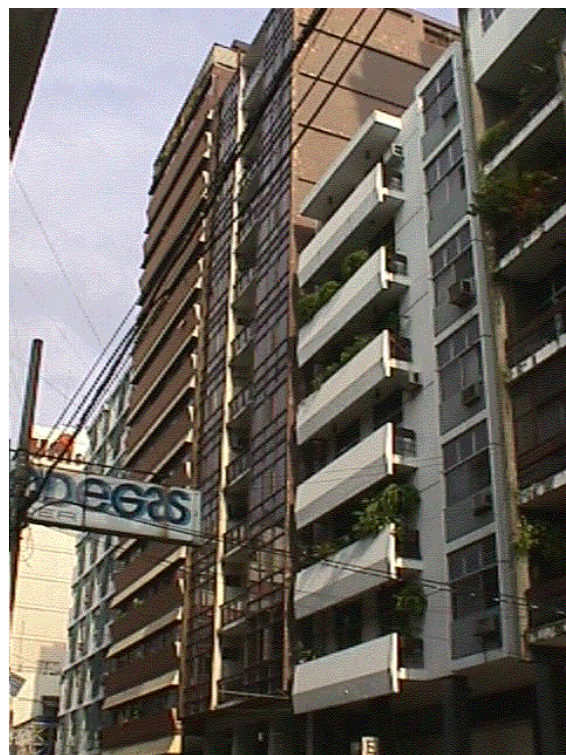
The custom to build buildings very close to each other, specially when they are of different heights, produces harmful effects in the structures because they do not behave as they were designed to, and can cause mutual damage because of the impact (pounding) against each other. This factor is very common in buildings in the Central Zone. See figure 24.

Figure 24. Example of type I building, leaning against each other and with risk of impact.

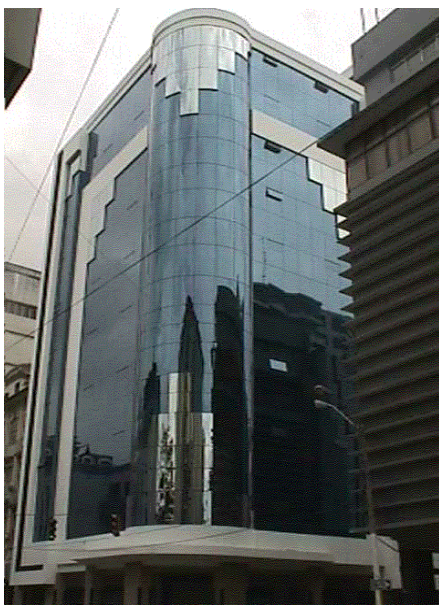
Figure 25. Building with “glass skin”

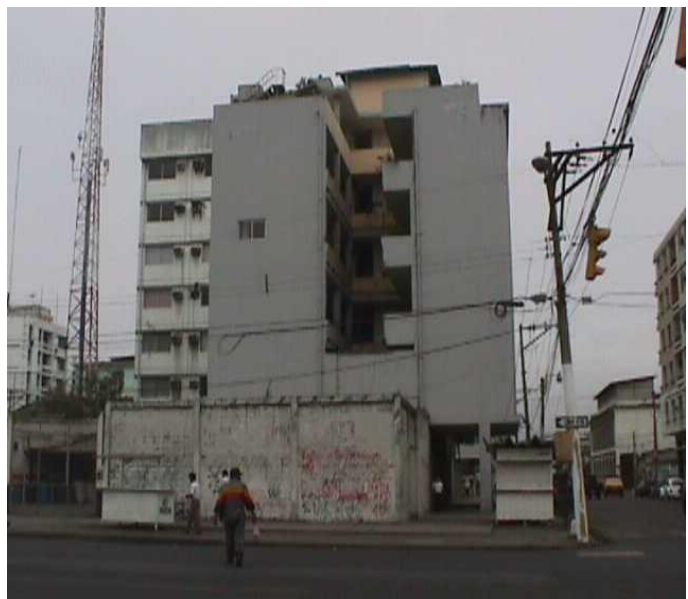
Buildings with architectural plans in the shape of L, T, H, U or I, have a poor seismic behavior with predominance of torsion, therefore they are more vulnerable to damage than those buildings with rectangular plans. Such situation also occurs when geometrical changes are done along the height of the building. See figure 26.

Figure 26. Building with irregular plan
